New Building Inspection Report - Lockup Stage

Monday, 29 / 11 2024 08:00 AM

New Building Insp. ction Lockup Stage

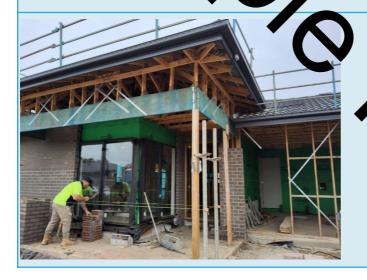
External Walls

It has been observed that the brick was new yet ally completed at the time of the inspection.

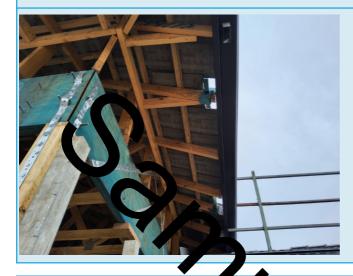
Eaves

It has been observed that the eaves were not yet completed at the time of the inspection.

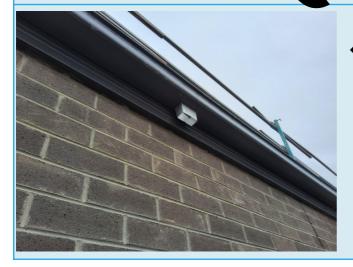
Downpipes

It has been observed that the downpipes were not set in taked at the time of the inspection.

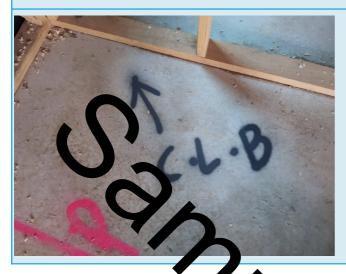
Bedroom 1, rear elevation left hand side, it has been observed at the cornice line appears to be bowed.

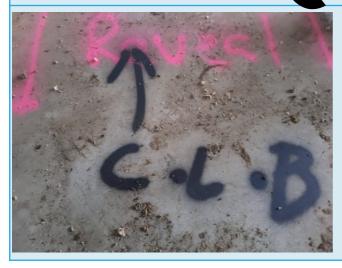
Ensuite, right elevation centre area, it has been observe at the cornice line appears to be bowed.

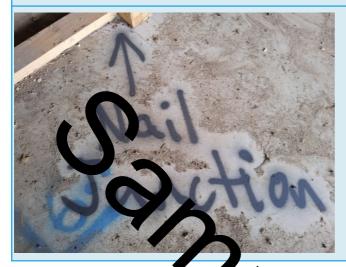
Bedroom 1, rear elevation right hand side, it has been observed that the wall corner junction has not yet been nailed off.

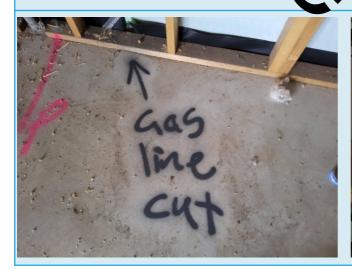
Bedroom 1, left elevation, it has been observed that the as one appears to be cut/not yet fully roughed in.

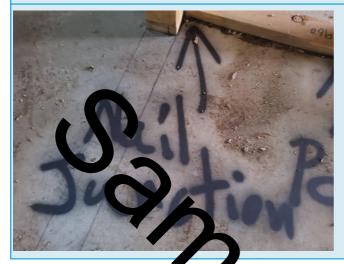
Ensuite WC, right elevation left hand side, it has been observed that the wall corner junction has not yet been nailed off.

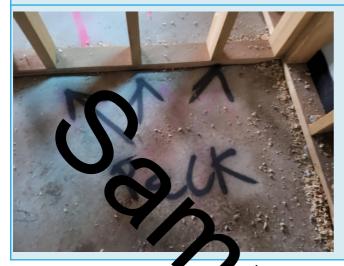
Ensuite, front elevation right hand side, it has been observed that the wall requires straightening.

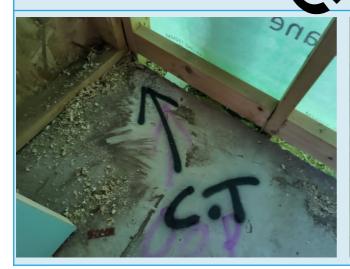
Theatre, front elevation left hand side, it has been absenced that there appears to be a ceiling trimmer missing.

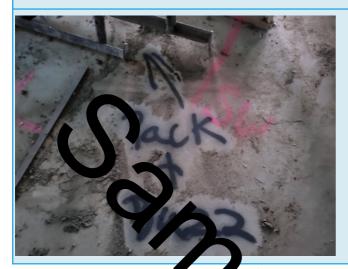
Kitchen, front elevation, it has been observed that the wall requires straightening.

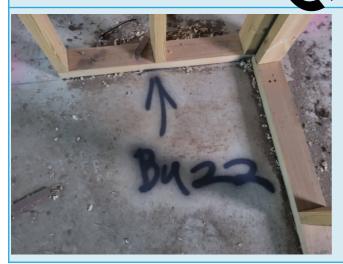
Pantry, front elevation right hand side, it has been observed that the wall requires straightening.

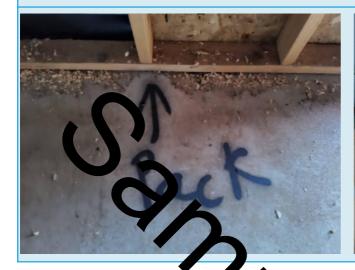
Bedroom 2, right elevation left-hand side, it has been observed that the wall requires straightening.

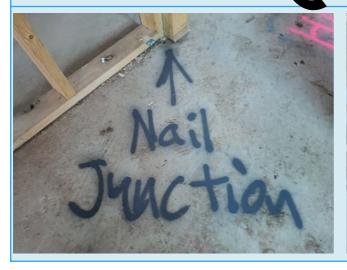
Bathroom, rear elevation left-hand side, it has been ob

that the wall corner junction has not yet been nailed off.

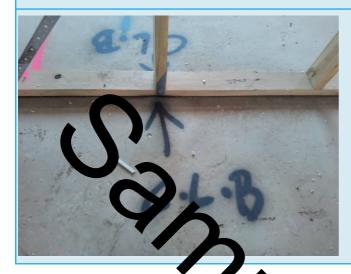
Rumpus, rear elevation centre area, it has been observed at the cornice line appears to be bowed.

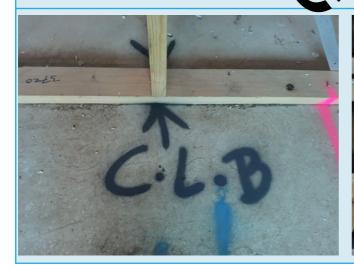
Bedroom 4, front elevation centre area, it has been observe at the cornice line appears to be bowed.

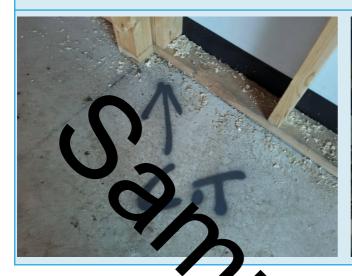
Bedroom 4, front elevation right hand side, it has been observed that there appears to be a ceiling trimmer missing.

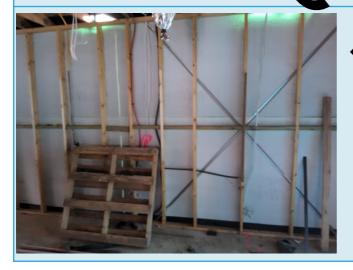
Insulation

It has been observed that the wall insulation was at year, alled at the time of the inspection.
